## OLT BIP8 Error

When the OLT shows a BIP8 error, it means that there are communication errors from the OLT to ONU and optical link quality issues.

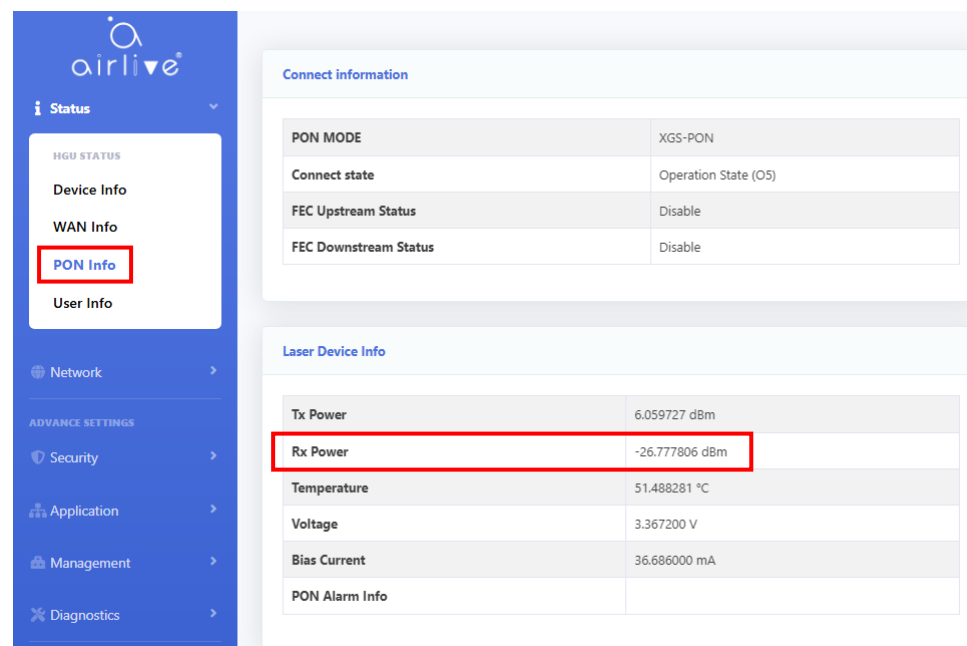
1) Please verify the ONU RX power in the ONU Web interface. Typically, the ONU RX power should be within the range of -3dBm to -28dBm.

The image below shows the AirLive ONU-10XGS-1004-10G as an example.

If ONU RX power shows '-inf' after fiber plug-in, please replace PON module and/or replace a with another ONU to check.

2) Please replace the PON module with another module.

3) Please replace the ONU with another ONU.
