OLT is unable to Authenticate ONU

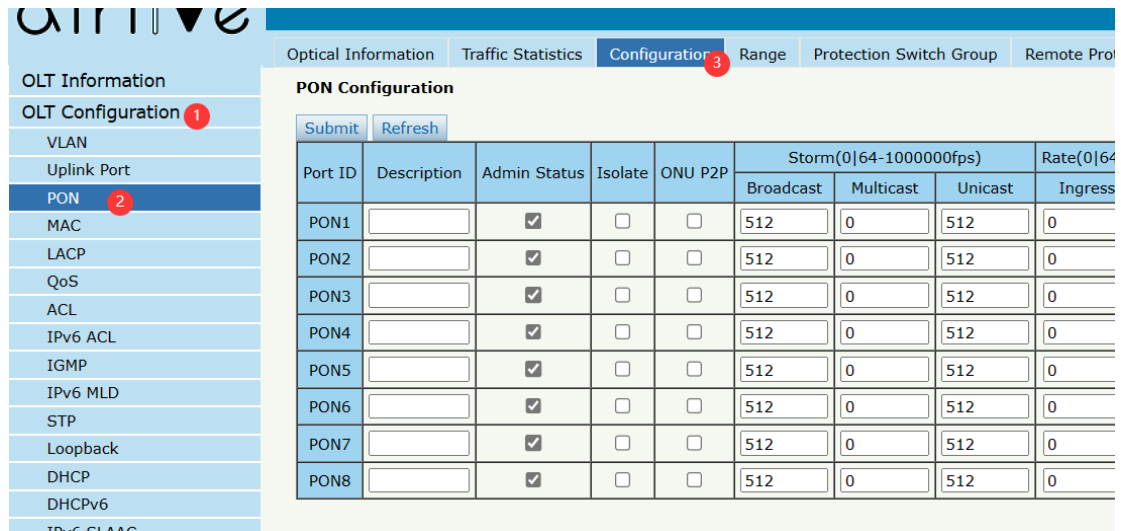
OLT Configuration>PON>Configuration>PON>Admin Status

1. Please ensure that the OLT has enabled the PON port.

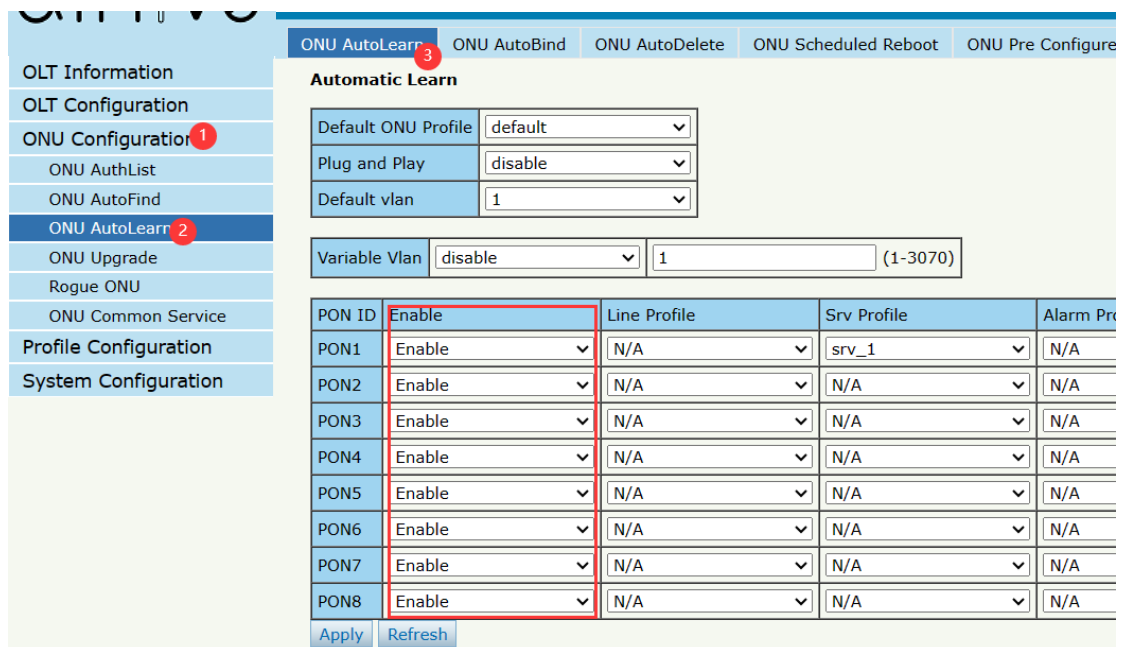
GPON/XG(S)PON: ONU Configuration>ONU AutoLearn>Enable PON AutoLearn (OLT WEB)

2. Please ensure that the OLT has enabled Auto Authentication for the ONU.

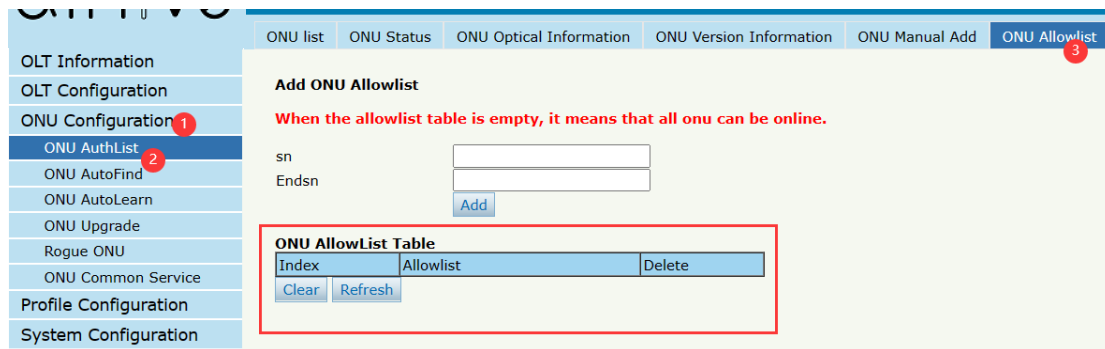
GPON/XG(S)PON: ONU Configuration>ONU Allowlist (OLT WEB)

3. Please verify the OLT blacklist table, to ensure that the ONU is not listed.

Typically, the table should be empty.

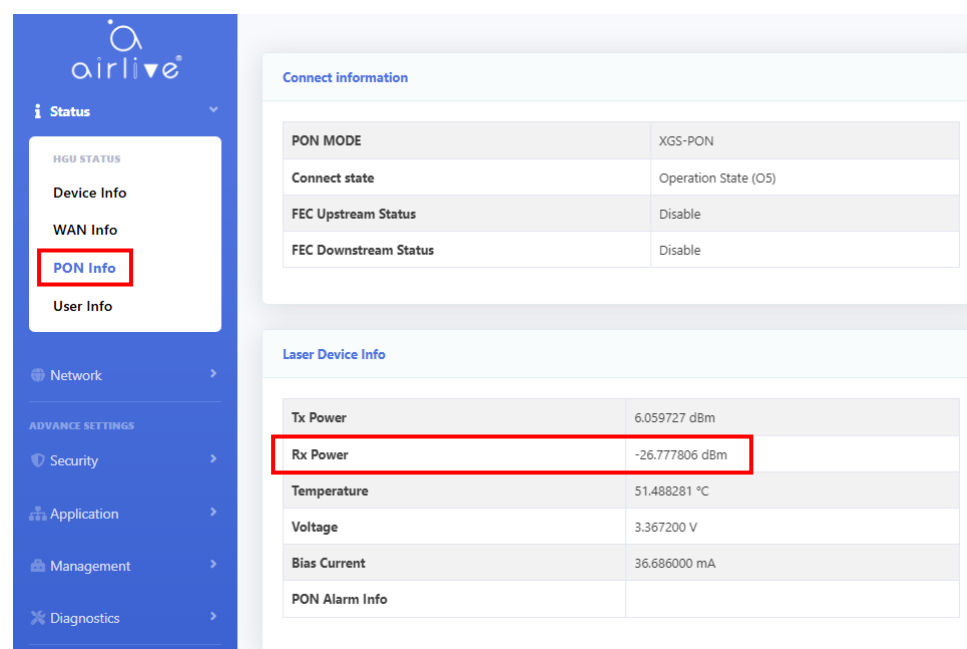
5. Please verify the ONU RX power in the ONU Web interface. Typically, the ONU RX power should be within the range of -3dBm to -28dBm.

The image below shows the AirLive ONU-10XGS-1004-10G as an example.

If ONU RX power shows '-inf' after fiber plug-in, please replace PON module and/or replace a with another ONU to check.

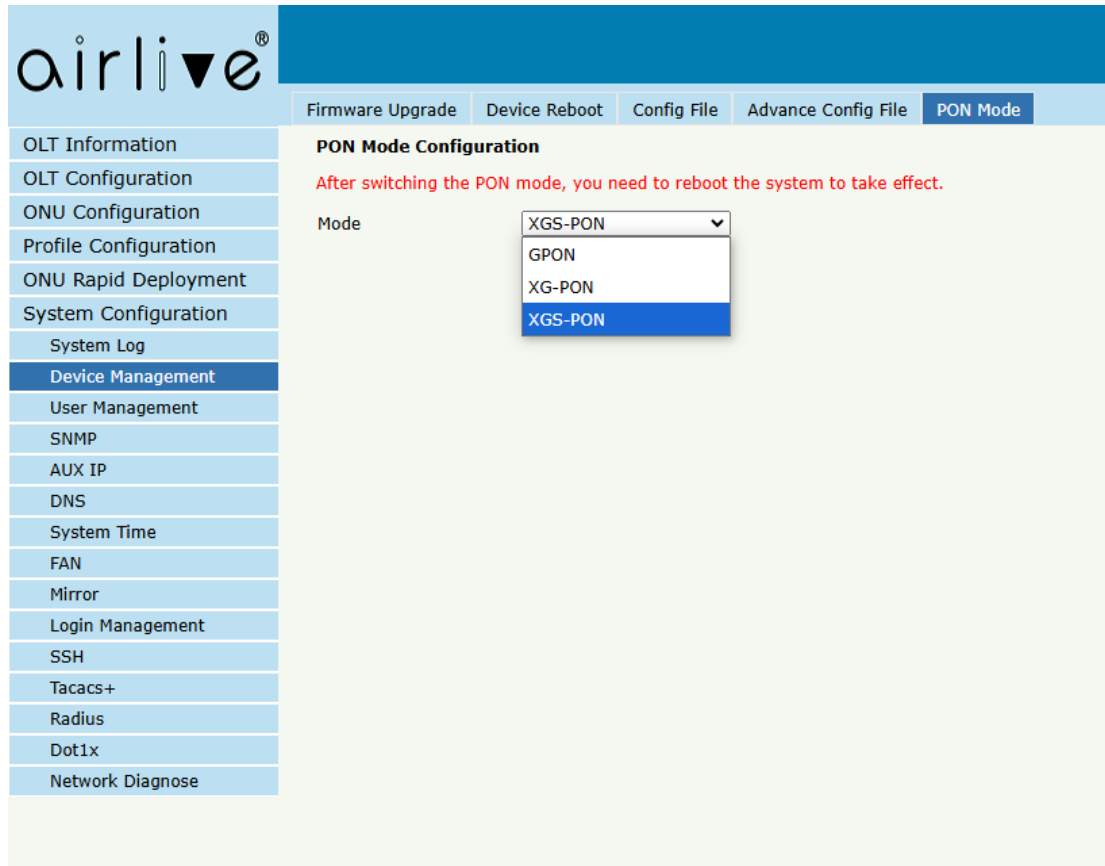
System Configuration>Device Management>PON Mode

6. Please verify the ONU PON Mode.

If you are using an AirLive XG(S) OLT, the OLT should be in the correct PON mode for the ONU which will be connected to it. Note that the correct PON module is also used.

The image below is an example of the AirLive OLT-2XGS.
